FATIGUE IN SINGLE CRYSTAL NICKEL SUPERALLOYS

Technical Progress Report

15 October, 1994

Contract N00014-91-C-0124

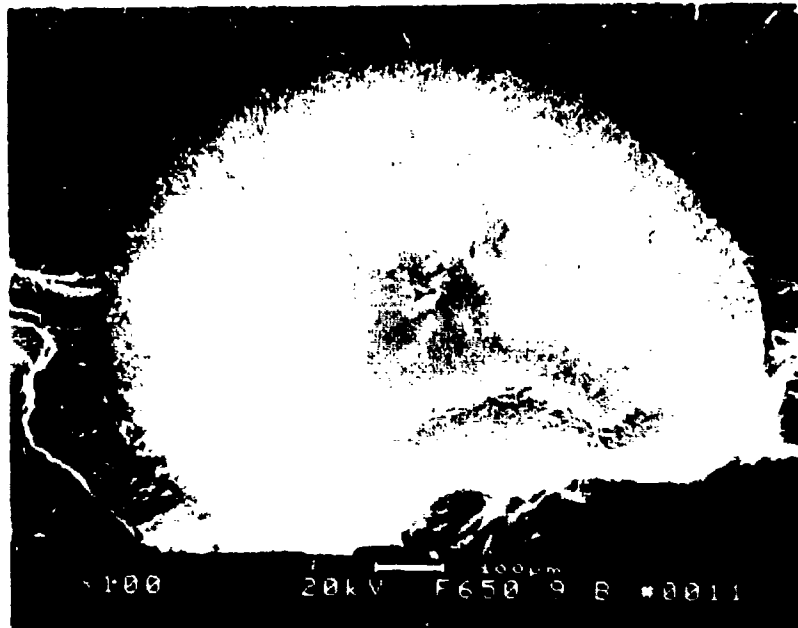
Figure 2. Non-crystallographic fatigue crack initiation in PWA 1484 at 1400°F.

Based on a review of PWA 1484 failed specimens, the tendency for crystallographic versus non crystallographic fatigue crack initiation appears to be inversely dependent on temperature and stress in notched LCF (Figures 1 and 2). The trend was noted in notched low cycle fatigue tests conducted with non-hipped PWA 1484 at 1100 F, 1400 F and 1600 F. This observation suggests that an activation energy, in terms of frequency, temperature and stress, can be determined to predict the conditions favoring (111) initiation. This behavior was previously reported by Leverant² in single crystal Mar-M-200.

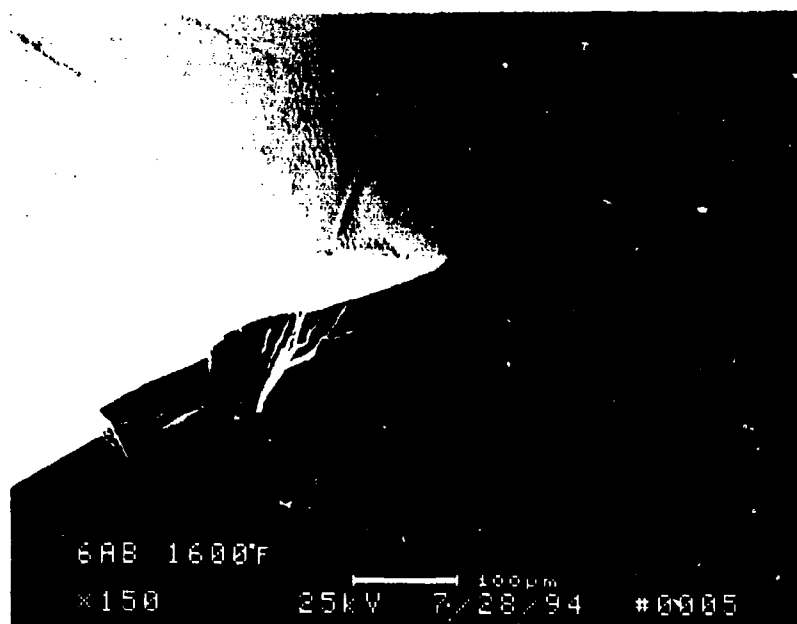
Figure 13: Mixed mode HCF crack initiation (internal origin at TaC) in PWA 1484 at 1600° F. Hexagonal crack front is an artifact of the operative slip systems.

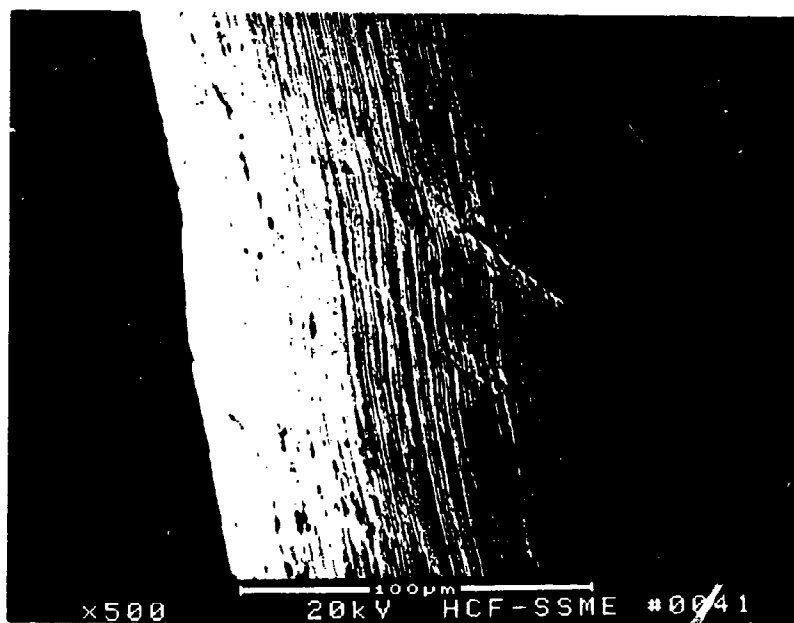
Figure 5. A 0.002" crack forming along a persistent slip band. The amount of slip displacement can be seen silhouetted at the specimen surface.

Cyclic stressing produces alternating slip reversals that progress to slip band extrusion. Surface crack initiation occurs at these extrusion/intrusions aided in air as an oxidation mechanism precludes slip reversal. A single slip system is able to advance a crack under these circumstances. Our observations suggest that a critical slip displacement is reached before fracture can occur. A higher magnification view (Figure 5) of the specimen shown in Figure 3 reveals a 0.002" crack forming along the persistent slip band at the specimens surface.
